Survey No. T-830

Maryland Historical Trust State Historic Sites Inventory Form

1. Nam	e (indicate pr	eferred name)		
historic				
and/or common	Bud Larrimore	House		
2. Loca	ition			
street & number	Barneck Road			not for publication
city, town	Barneck	vicinity of	congressional district	Fifth
state	Maryland	county	Talbot

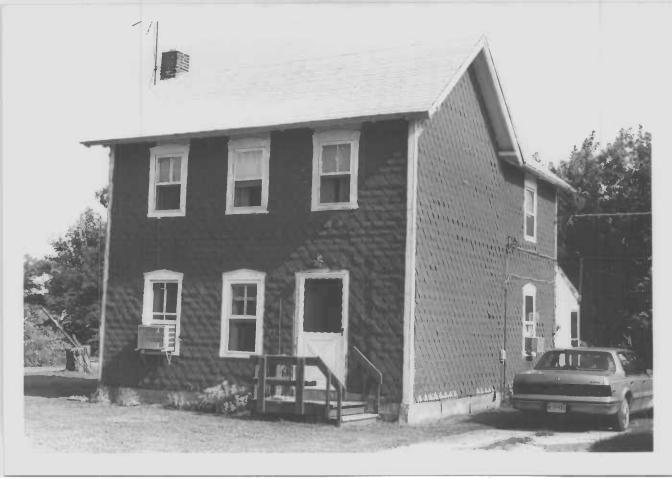
7-835

The three bay south 'main' facade of the Larrimore house has a pair of two-over-two sash windows with wide surrounds and peaked crown mouldings. An entrance door serves as the eastern bay. The second floor is lit by three two-over-two sash windows with wide surrounds and peaked crown mouldings. The open eave has exposed rafter feet.

TILGHMAN ISPAL, TALBOT COUNTY, MILL
SOUTH CAST CIEWITTAL
